FABRIC DEFECTS

CASE HISTORIES OF IMPERFECTIONS
IN WOVEN COTTON AND RAYON FABRICS

J. B. GOLDBERG

Fellow of the Textile Institute
Research Director, J. P. Stevens & Co., Inc.

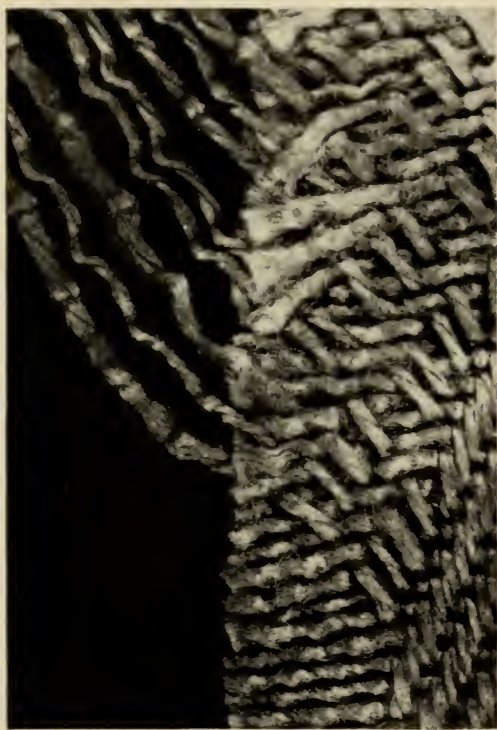
As indicated above, the warp yarns in these goods were supposed to have been two-ply 36's cotton. Analysis of a large number of consecutive ends taken from the fabric showed wide variations in the size of the single yarns. Actual size range was from 32's to 43's, with the twist varying from a low of 16 turns per inch to a high of 30 turns per inch. The ply twist was also very irregular, running from as low as 14.3 to as high as 17.6 turns per inch. The variations in yarn size and twist resulted in differences in light reflection, producing the streaky warp appearance. In this particular case, the yarns had been purchased by the weaving mill from a commission yarn spinner, who eventually assumed all responsibility.

FIG. 1a. Uneven yarns in fabric.

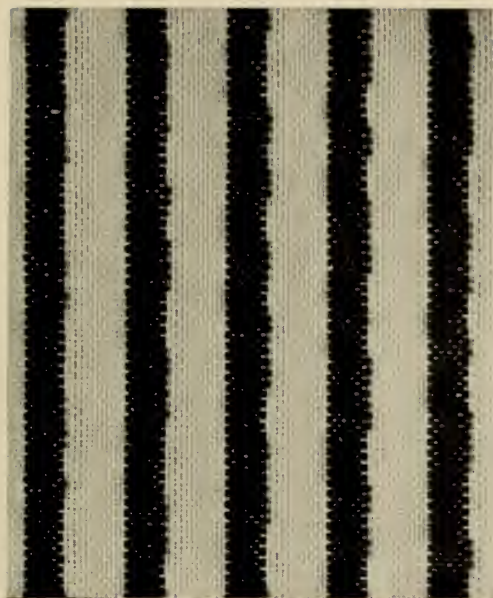
FIG. 34a. Normal seersucker.

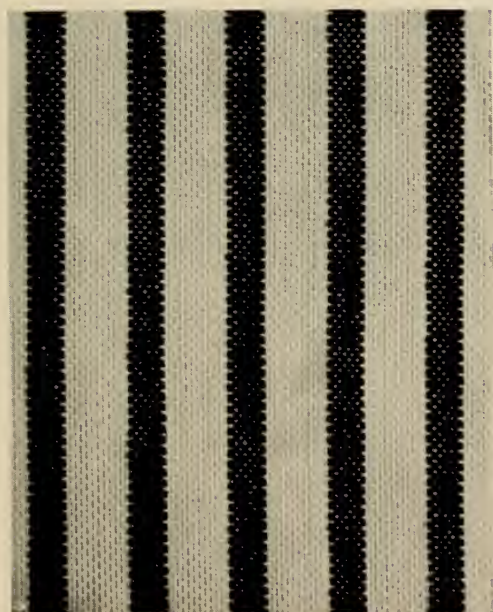
In a woven seersucker construction, the pucker is obtained by taking the warp yarn from two beams. One is held under ordinary tension for the ground weave, while the other is allowed to run slack, to permit the weaving in of those warp yarns at a faster rate, producing the crinkled effect. It was first suspected that the flat-appearing pieces had been excessively stretched in finishing, so that some of the crinkle was pulled out; but analysis of the pick count proved that the warpwise shrinkage in finishing was exactly the same in both the normal and the flat pieces. The lack of pucker was attributed to too much tension on the slack beam during weaving, which resulted in insufficient contraction in the colored stripe. Take-up of this yarn in one of the normal pieces was found to be 29.5%, whereas in one of the flat pieces it was only 17.5%.

FIG. 34b. Flat seersucker.

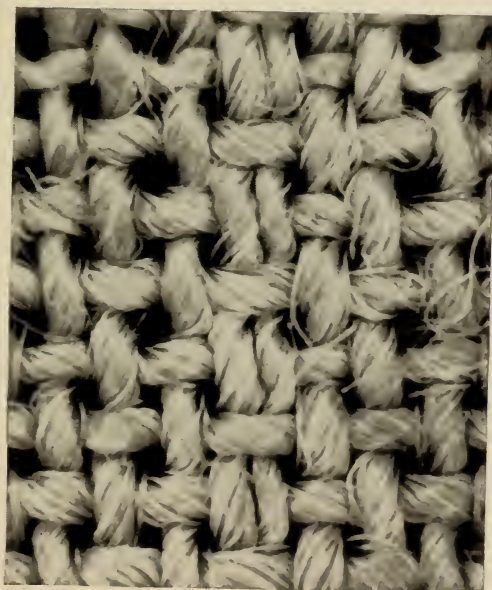
FIG. 35b. Enlarged view—two ends weaving as one.

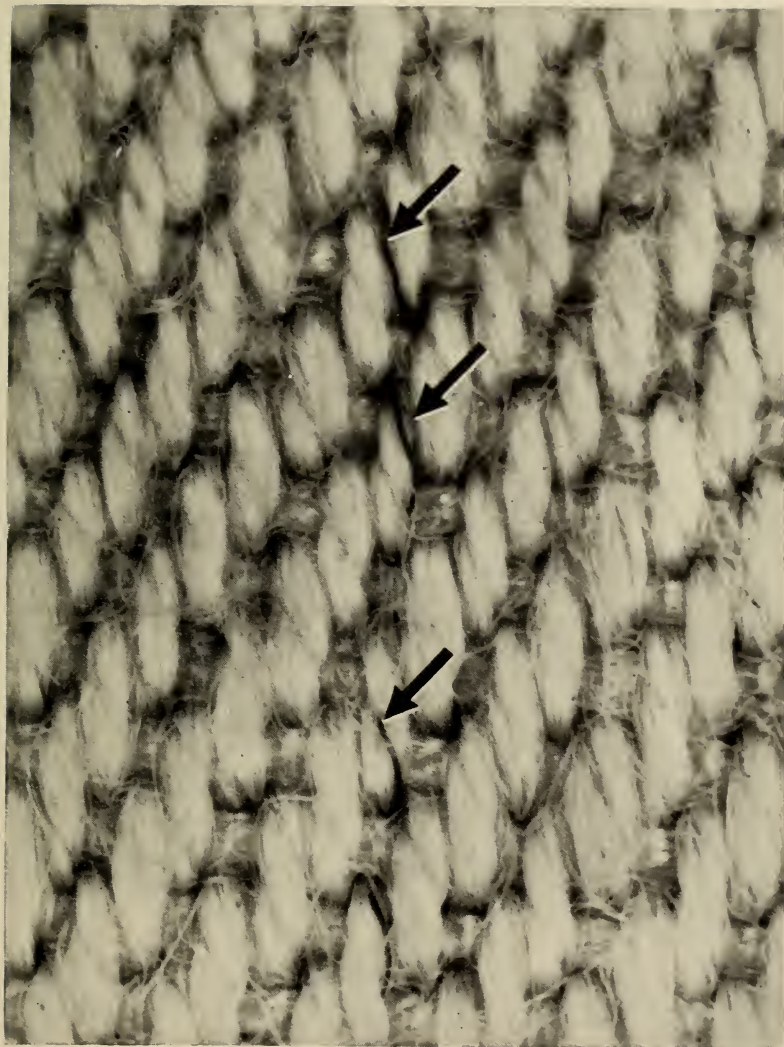
Analysis showed that the short dark streaks were due to the presence of numerous dark-brown and black wool hairs spun in with the regular yarns. When wool is used for blends to be finished in white or light shades, it must be especially selected for freedom from black hairs, since there is no means of removing or bleaching them in finishing.

FIG. 36. Black hairs in white finished goods.

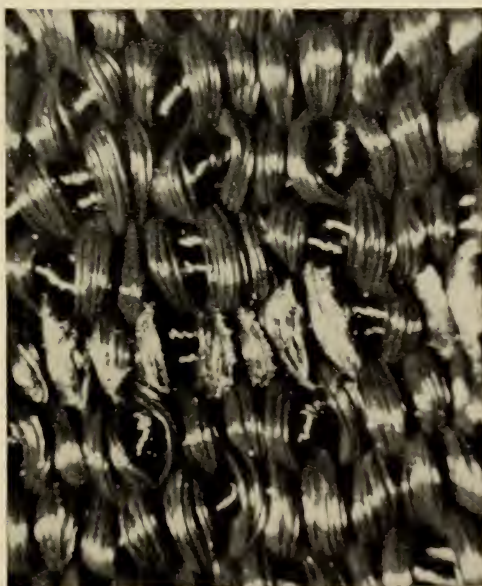
FIG. 45b. Warp yarns bruised by shuttle.

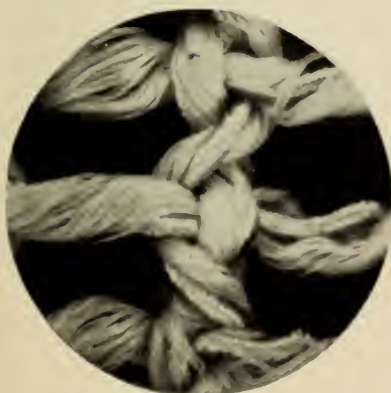
FIG. 46b. Normal—S twist crepe.

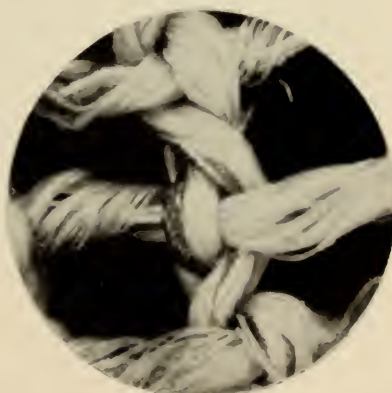
FIG. 46c. Defective—Z twist crepe.

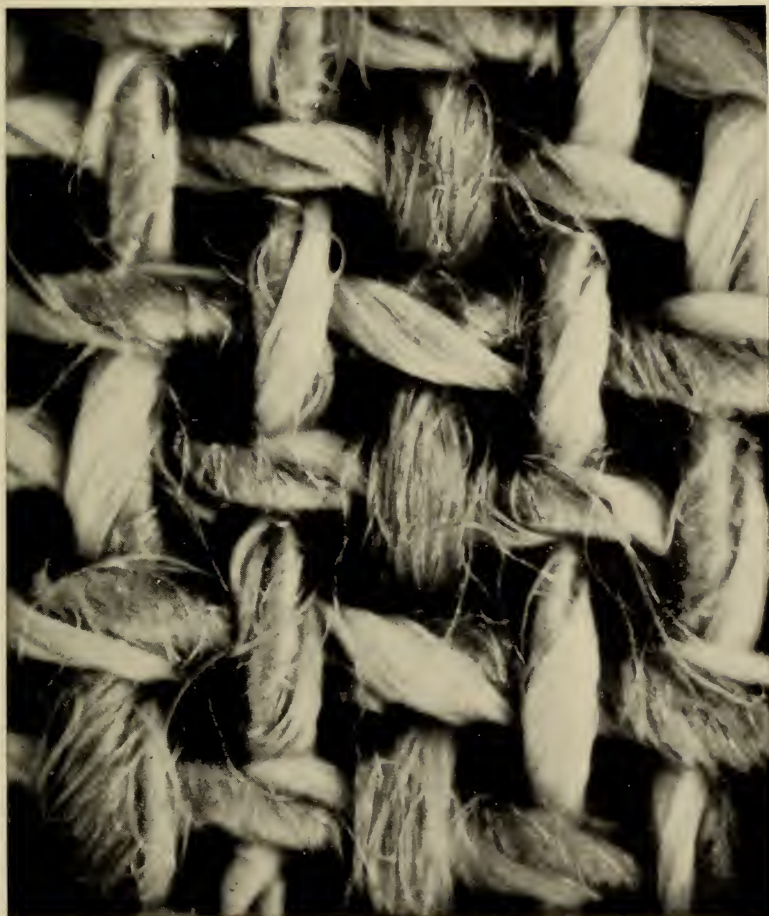
Analysis showed that the dark-dyed end was composed of two plies of all-viscose spun rayon, instead of one end of viscose and one of filament acetate, as specified. It was later determined that this was a selvage end, which had accidentally been woven into the body of the fabric. Being all viscose, it was dyed solid blue and was revealed as a dark streak.

FIG. 50. End composed of all-viscose rayon.

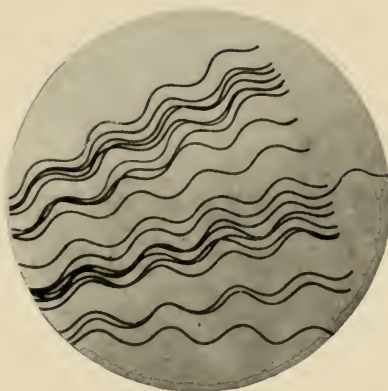
The dark streaks were confined to single warp yarns in which the denier and the twist were found to be normal. The filament counts, however, were subnormal, varying in the individual ends from 19 to 45, instead of the standard 60. It was evident, therefore, that more than one cone of the original yarn was involved. The fewer filaments are proportionately coarser and dye darker than the normal-sized filaments. This defect is usually due to clogged holes in the rayon spinnerettes through which the viscose solution is extruded in the spinning process. The defective yarns provide less cover than do the normal yarns, and in extreme cases the defect may be seen in the gray goods, presenting a "cracky" appearance. If similar low-filament yarns are woven in the filling, they will show up in the dyed goods as dark filling bands.

FIG. 57b. Defective, 19 filaments.

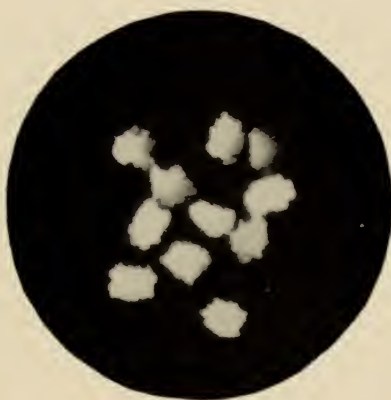
FIG. 57d. Defective, 11 filaments (cross section).

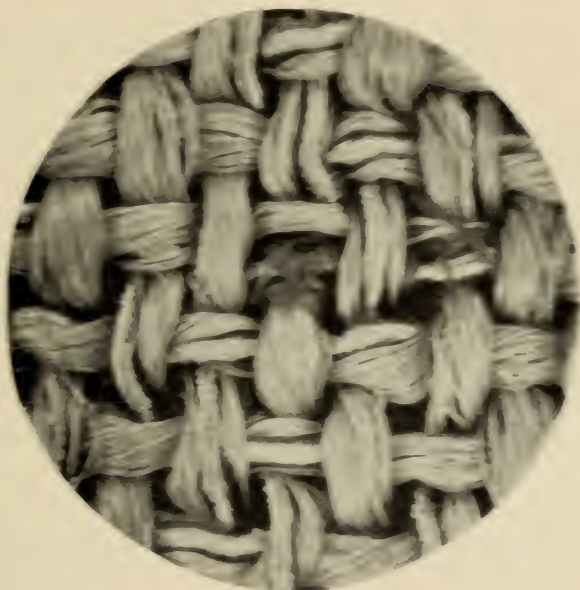
Microscopic analysis showed that the dark-dyed specks were actually comparatively coarse single filaments protruding from, but still making up part of, the continuous-filament viscose-crepe yarns. Only the extreme free ends of these filaments were coarse and dark, the remainder tapering off to normal size and shade. This defect, which would not be noticeable in white or dark-dyed goods, was attributed to faulty rayon manufacture, resulting from a clogged hole in a spinnerette suddenly clearing or "uncorking," with a coarse gob of viscose forming on the tip end. The clogging of rayon spinnerettes is a serious problem to the yarn manufacturer. Poorly filtered viscose solution may be one source of clogging; but the chemical composition of the spinning bath may also be a critical factor. Numerous patents have been issued on techniques and formulas to prevent holes from filling up and producing excessively fine filaments or sub-normal filament counts.

FIG. 60a. Dark speck.

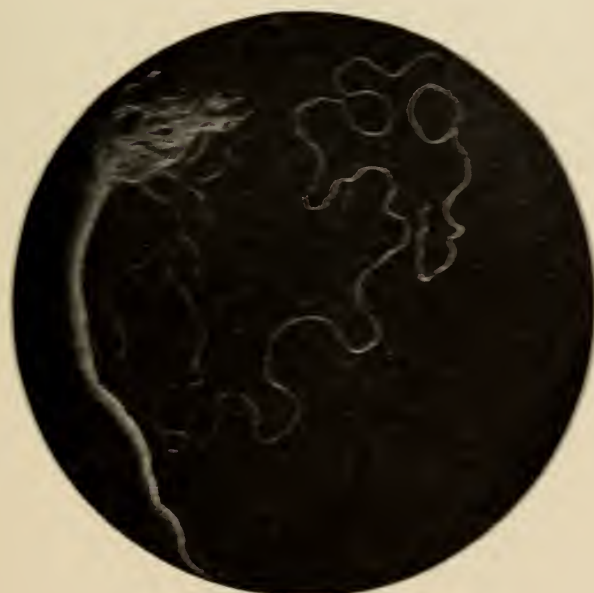
FIG. 60b. Single coarse filament.

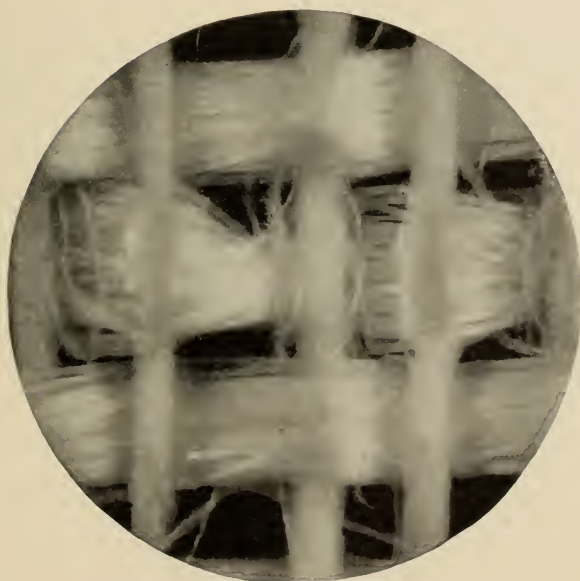
FIG. 61b. Twisting kink.

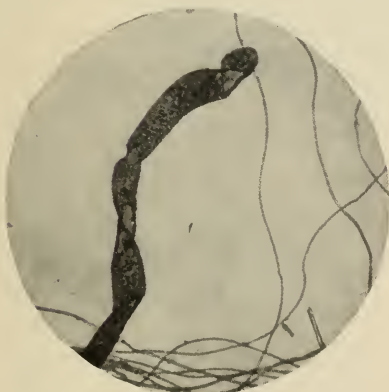
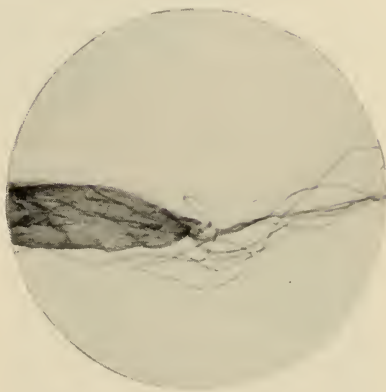
FIGS. 64c and d. "Splinters" of coarse fibers.

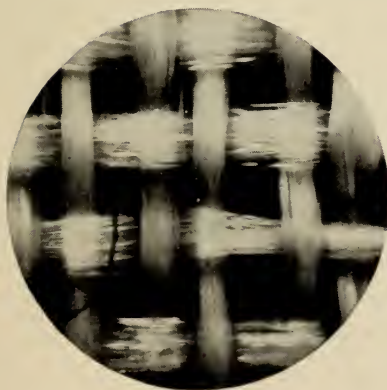
Microscopic examination showed that a large number of the filaments in the filling yarns in the streaky areas appeared to be bound together. It was impossible to pry them apart with a pick needle, and a thorough soap and soda-ash scour in the laboratory failed to open them up to a normal, full yarn. Further microscopic study of the cross sections in those portions of the filling confirmed the fact that a number of the filaments were actually bonded together. In some instances they gave the appearance of single filaments two or three times the normal diameter, with practically no line of demarcation between the several smaller filaments which had been "fused" together. This fault was attributed to some defect in the manufacturing of the yarn which allowed adhesion to take place before the filaments were completely hardened.

FIG. 65b. Thin section in yarn.

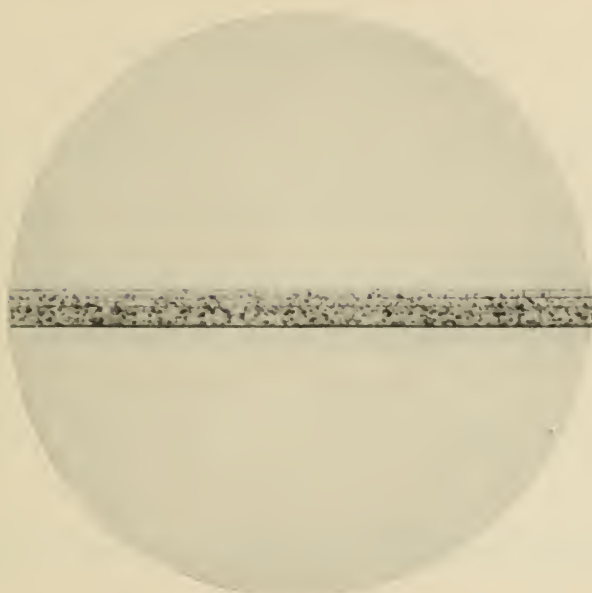
FIG. 66a. Normal pigment in filament.

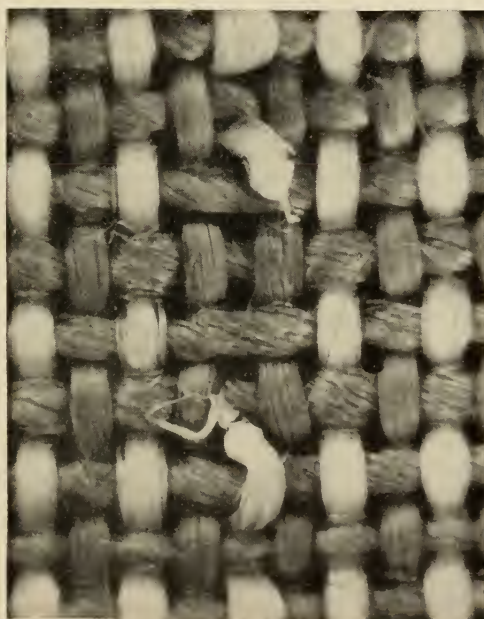
FIG. 73b. Single, partly dissolved acetate end.

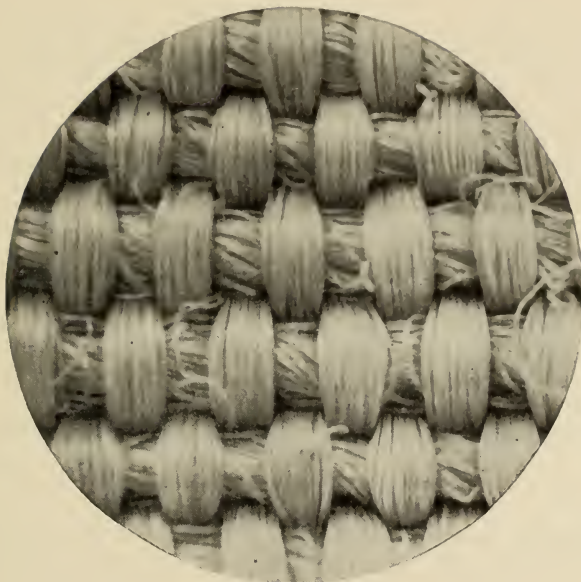
FIG. 80*a*. Normal area.

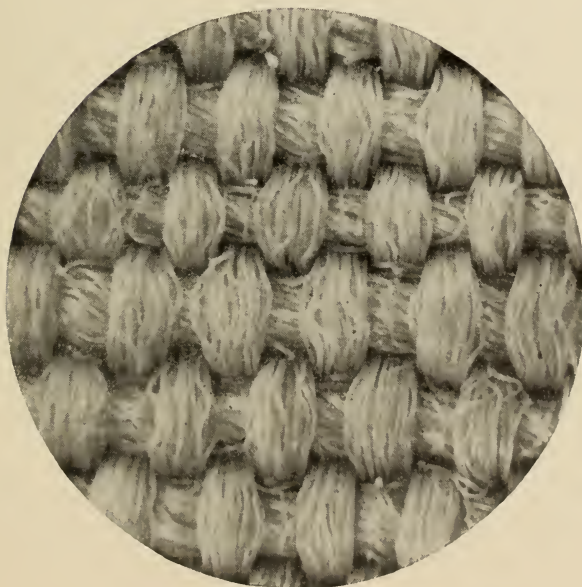
Inspection of the full piece showed several irregular streaks running in a warpwise direction on one face of the cloth only and varying from $\frac{1}{4}$ inch to 1 inch in width. Microscopic examination revealed a marked distortion of the filaments in the warp yarns in the streaky sections. Since there was no evidence of any gray-goods condition which could have been responsible for this damage, it was assumed that the defect was caused in finishing, probably by rubbing over some rough surface, but that it was not severe enough to rupture any of the yarns.

FIG. 80*b*. Streaky area—note warp yarn distortion.

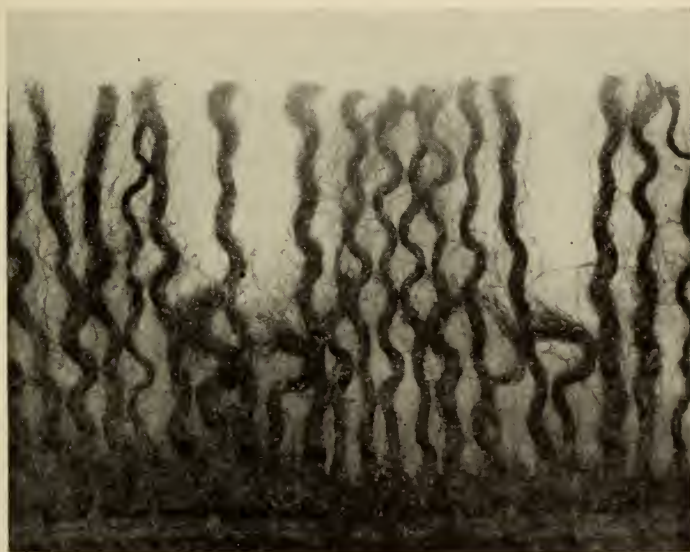
FIG. 81b. Cut ground yarns.

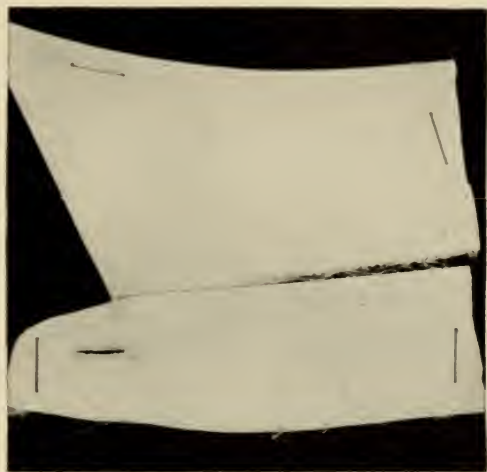
Tensile-strength tests made on cuttings of the white broadcloth from which these collars had been made indicated that they were normal and up to standard. Several of the collars were softened by the application of a solvent and the stitches were carefully removed at the seams where the tearing took place. It was found that both warp and filling yarns were cut excessively, in some places most of the filling yarns having been completely severed. Also, stitch length showed extreme variation, running from 12 to 22 per inch. In collars in which there were only 12 stitches per inch, the cutting was correspondingly less pronounced and the tear resistance was comparatively high.

FIG. 86a. New collar torn readily at seam.

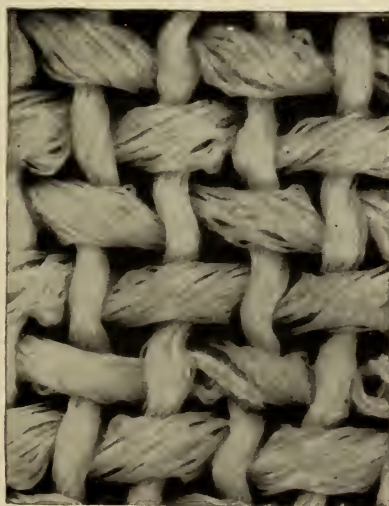
FIG. 94b. Undamaged area.

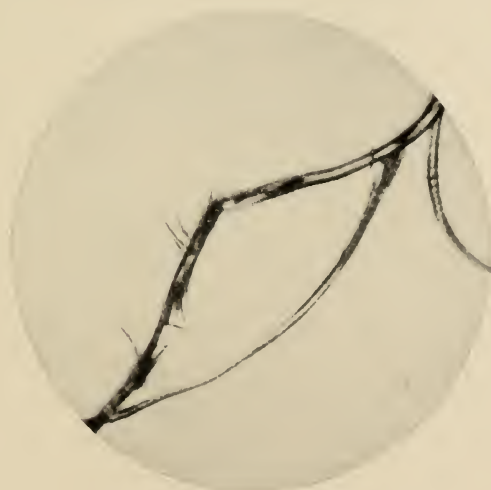
Microscopic examination revealed that the light streaks were due to the presence of single wool fibers which apparently did not take on the dyestuff. It was impossible to eliminate this condition by any known dyeing procedure. When the single fibers were studied more closely, it was evident that they were in a damaged condition. Although the exact cause of the damage to the fibers in the finished fabric was not determined, it was assumed that a small amount of one lot of wool had suffered mildew or bacteria attack, which made the fibers resistant to normally applied wool dyestuffs.

FIG. 96b. Damaged wool fibers.
